**Elevated Tank Inspection  
Town of Centreville  
Joseph Street Elevated Tank  
January 20, 2020**

Dungan Engineering, P.A.  
120 East Chickasaw Street  
Brookhaven, MS 39601

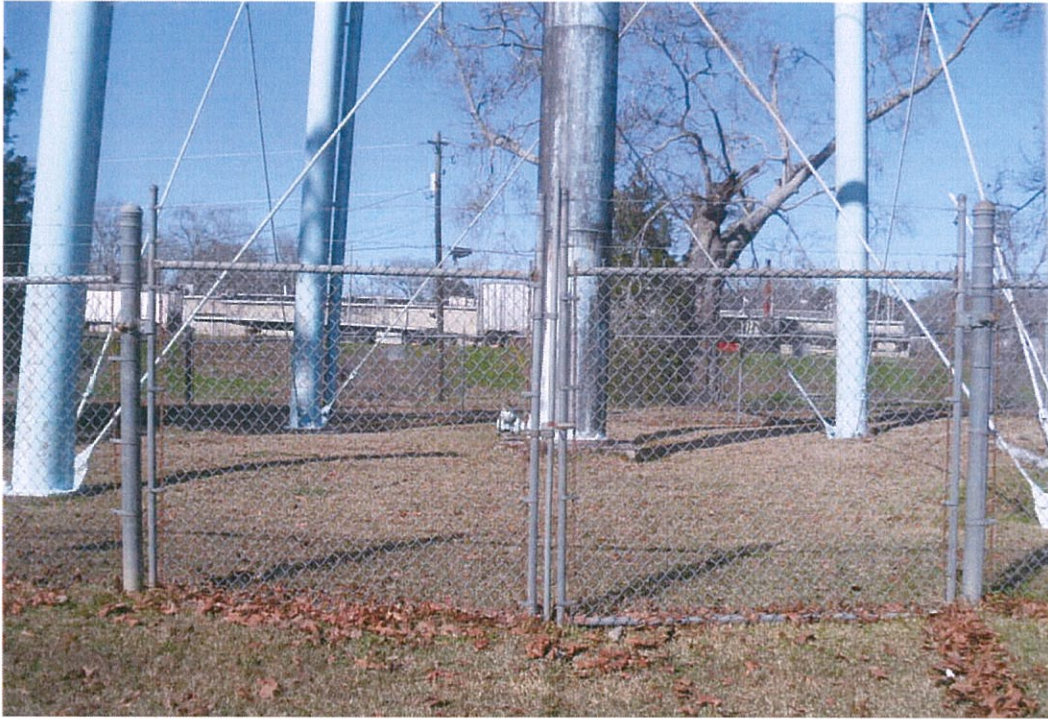
**Figure 1.** Locked entry gate

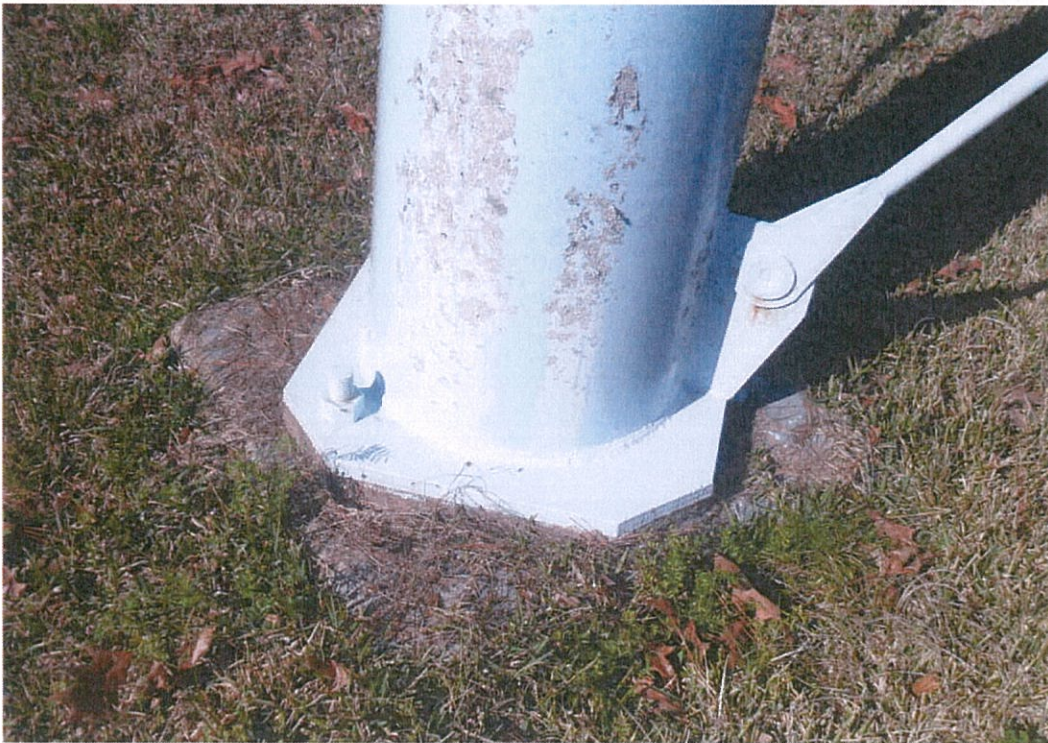
This portion of the tank is in good condition. The legs, wind-rods, struts, and column flanges are in good condition, but the protective coating is in poor condition. There are isolated areas of coating failure. There is complete coating failure and corrosion on the foundation, struts, and wind rods. There is a safety climb device on the tower ladder, but no anti-climb device at the base of the ladder.

**Figure 2.** Condition of tank support foundation

It is recommended that in the next 2 years, the exterior of this tank be blasted and coated to prevent deterioration of steel. The interior should be drained, and pressure washed for further inspection. It is also recommended that at the time of rehabilitation, the tank be brought into compliance with current AWWA specifications.

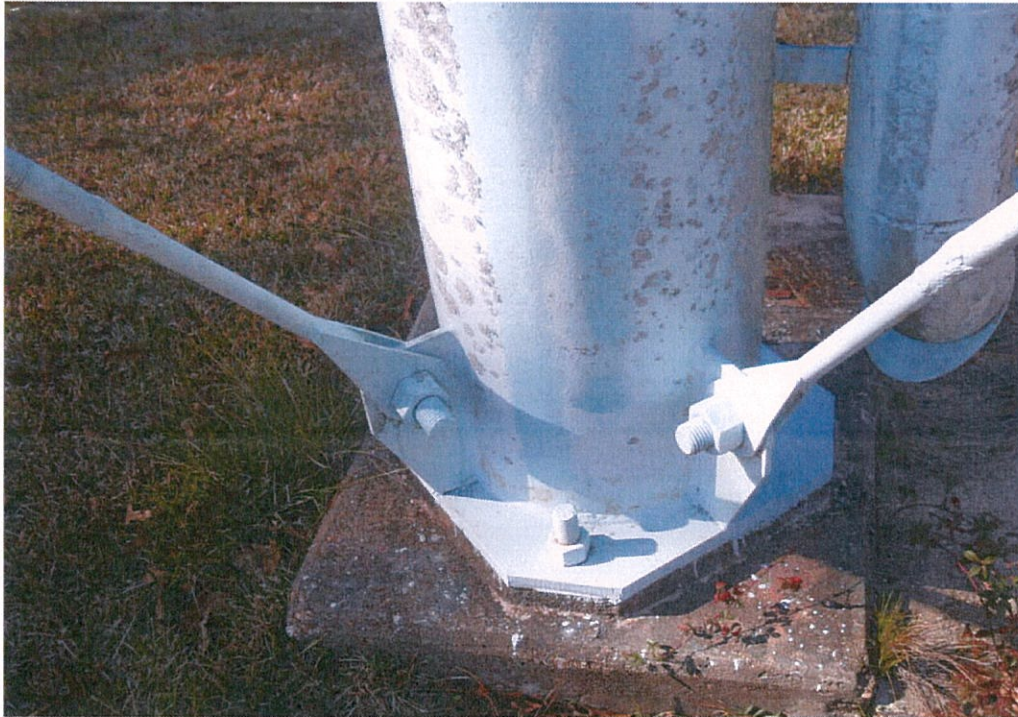
**Figure 3.** Condition of tank support foundation

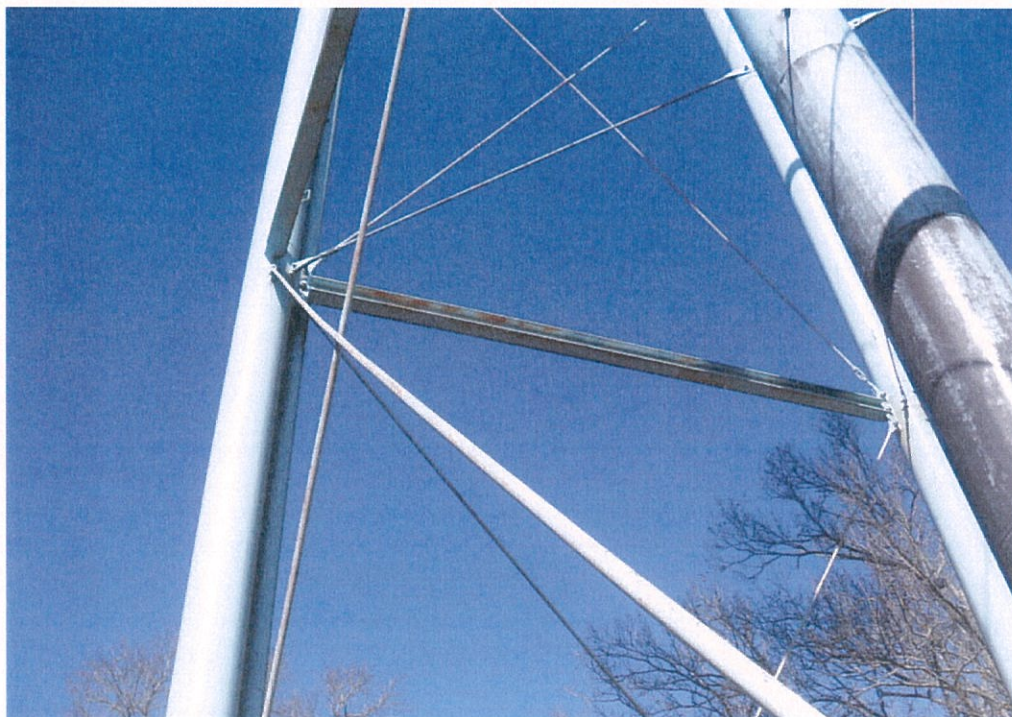
**Figure 4.** Coating failure on struts and heavy mildew on riser

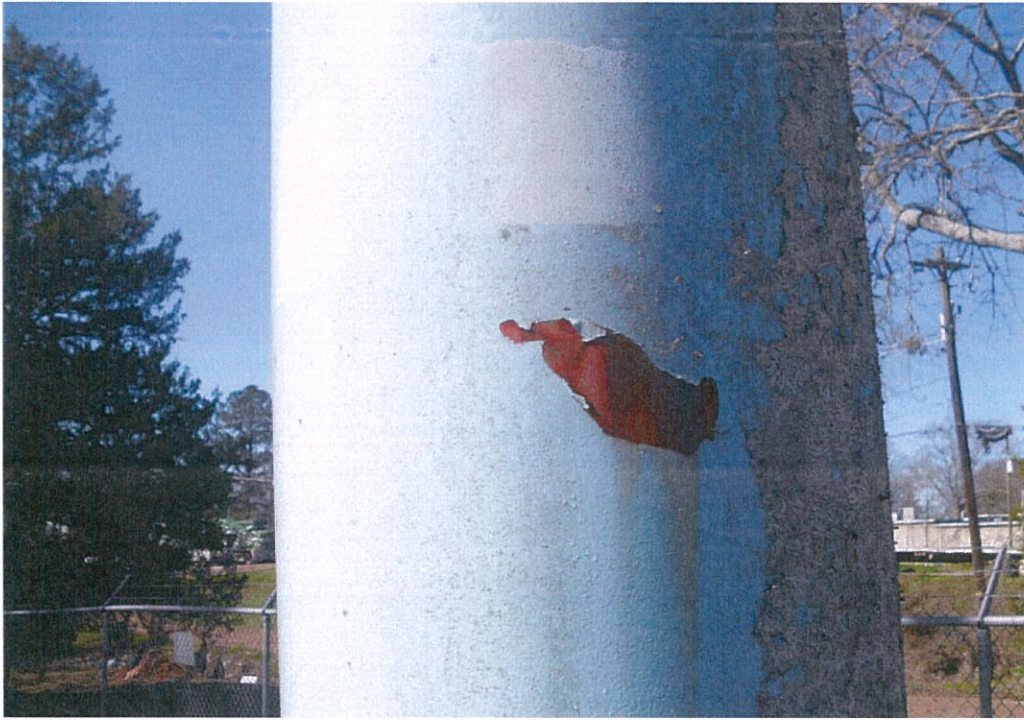
Figure 5. Coating failure on tank column

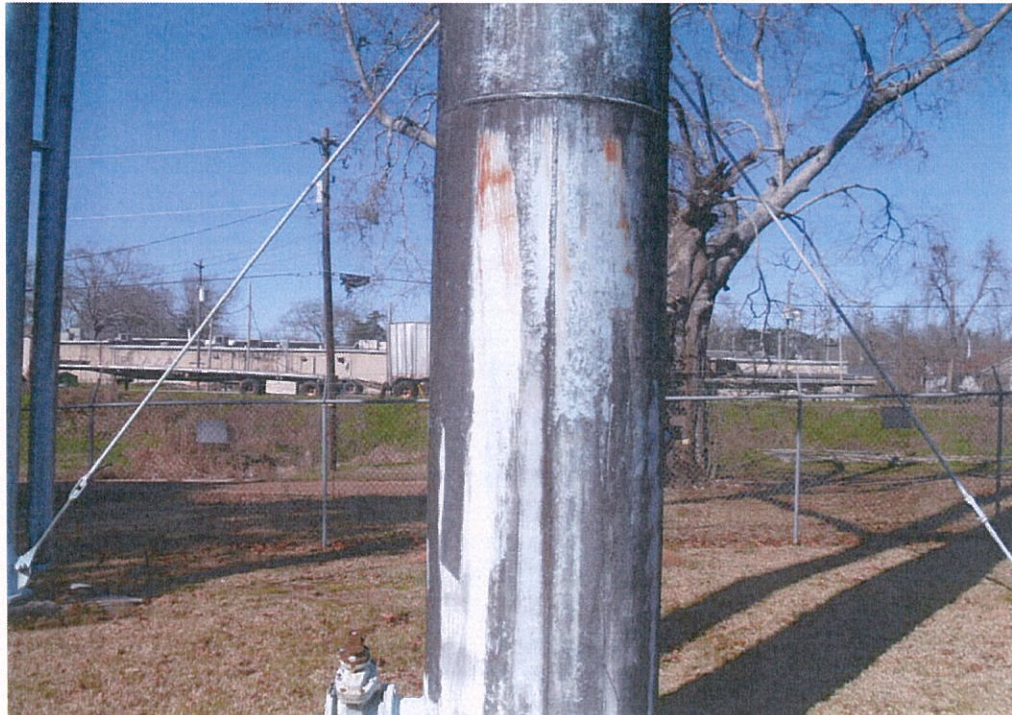
Figure 6. Coating failure on riser

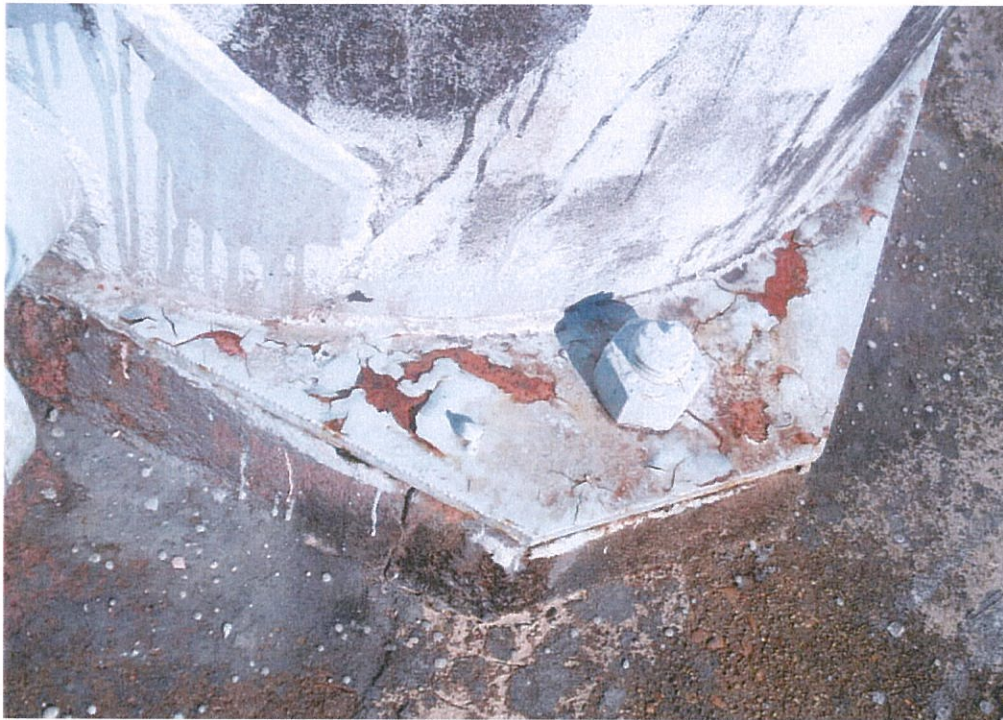
Figure 7. Coating failure on riser foundation

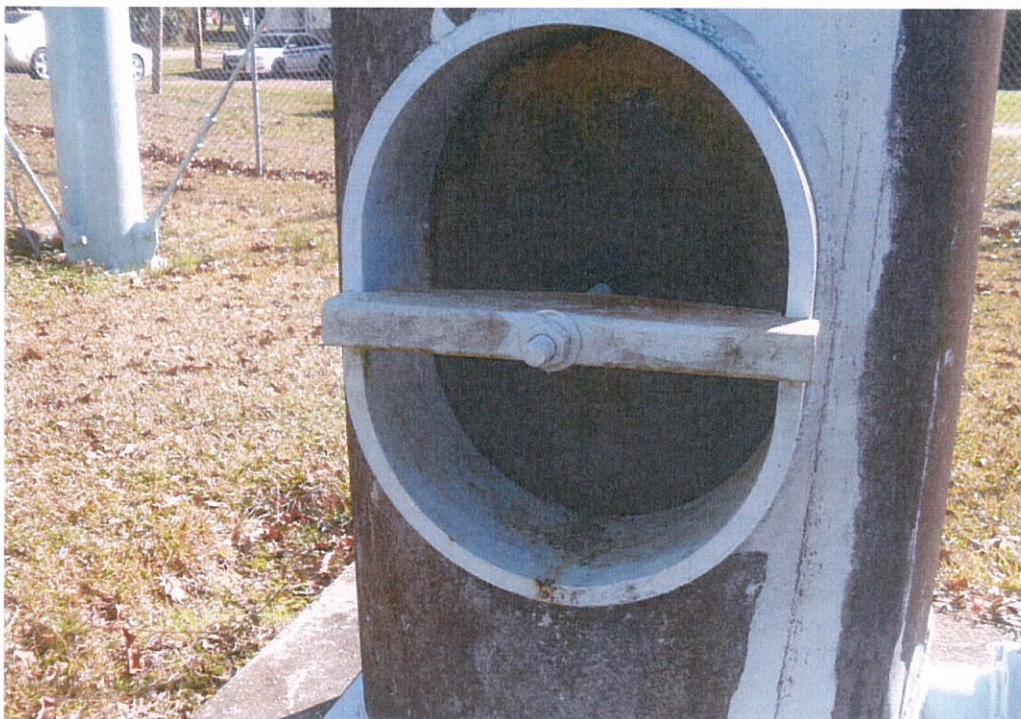
Figure 8. Riser manway

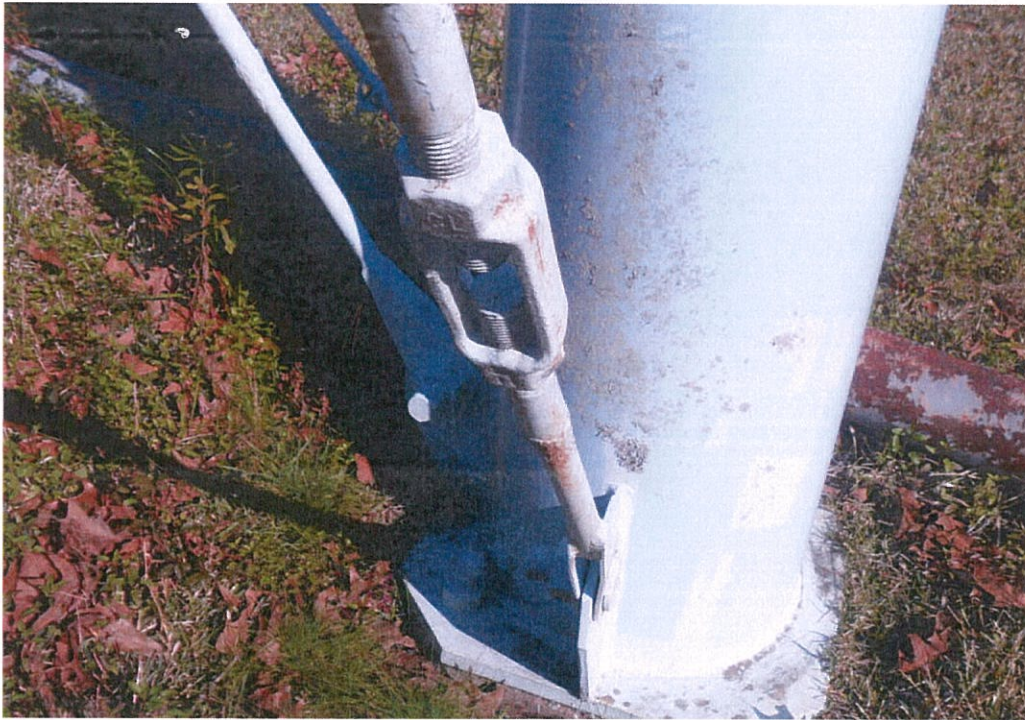
**Figure 9.** Coating failure on wind rods

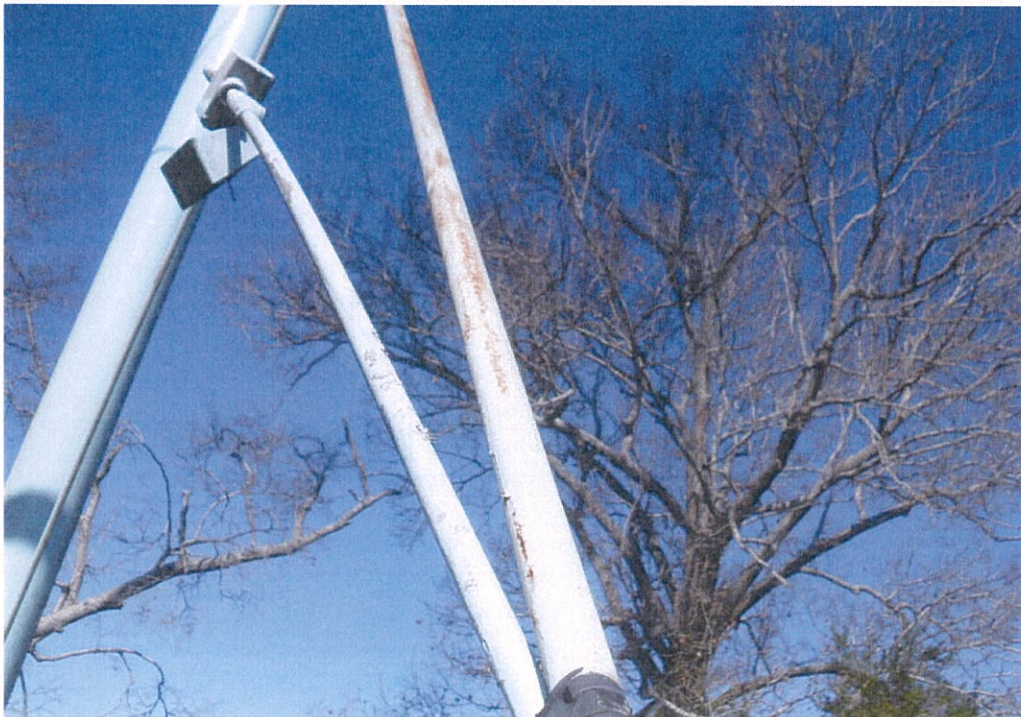
**Figure 10.** Coating failure on wind rod and broken electrical conduit

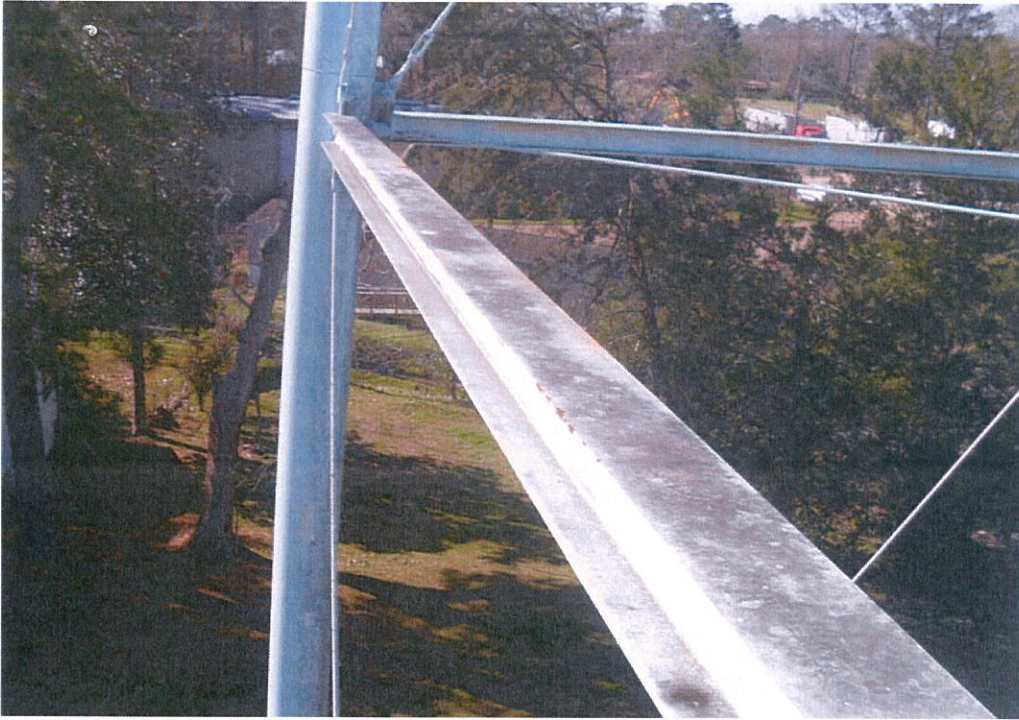
**Figure 11.** Heavy mold and mildew on first level struts

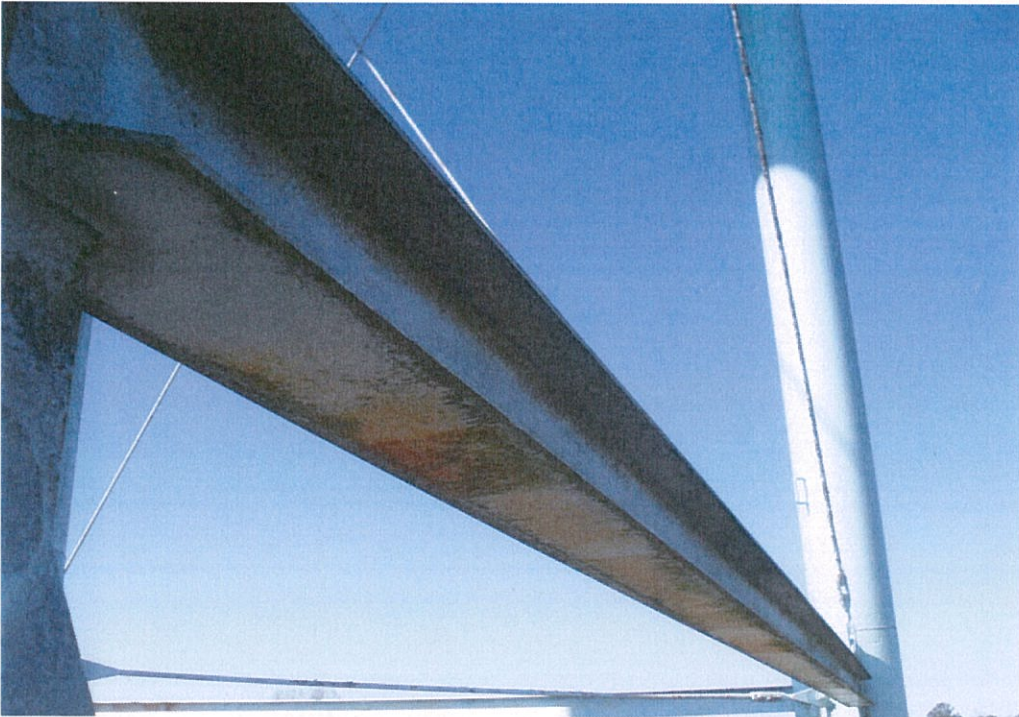
**Figure 12.** Coating failure on first level struts

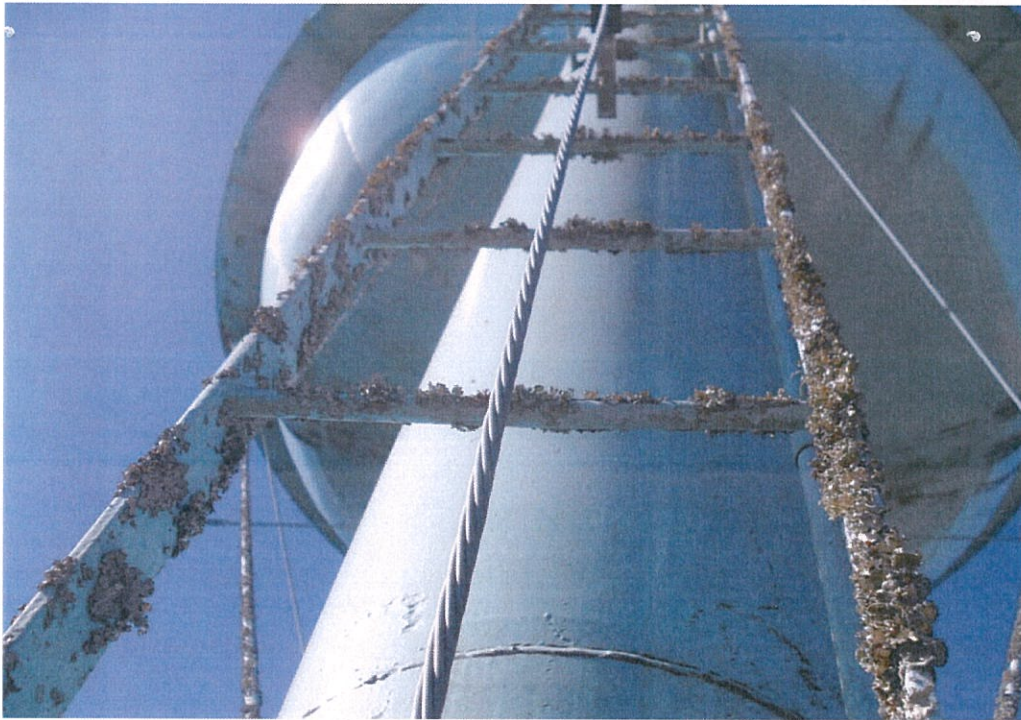
**Figure 13.** Heavy lichen growth on tower ladder

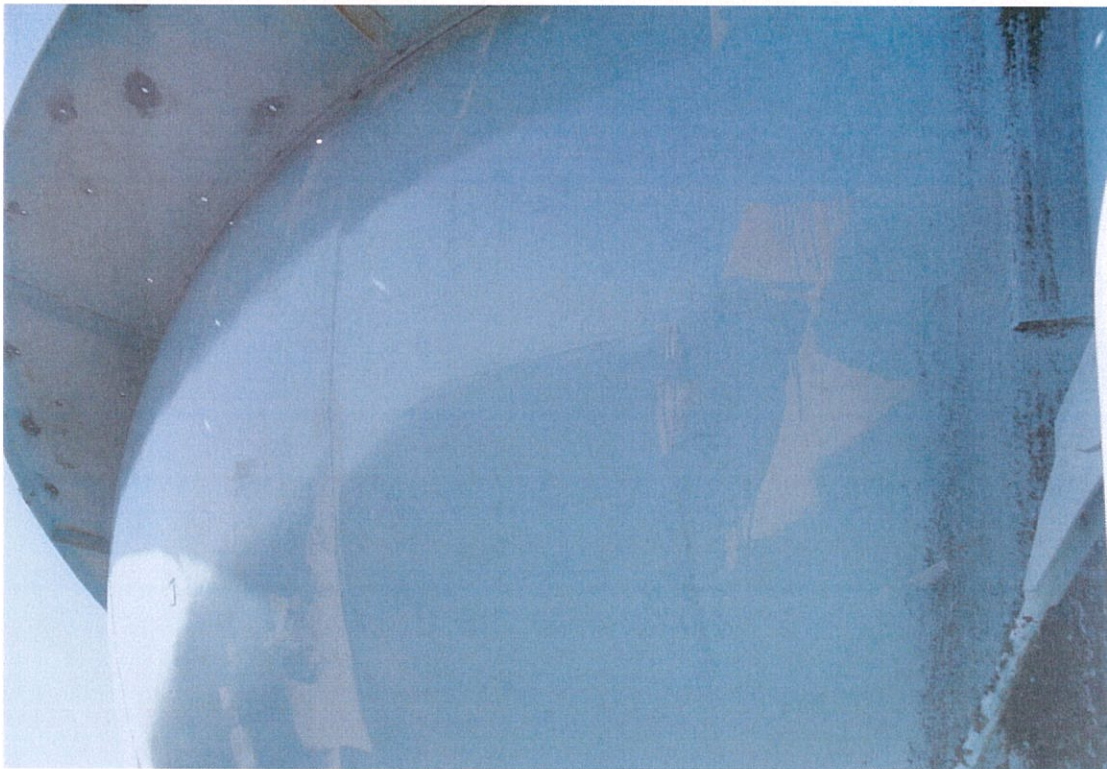
This portion of the tank is also structurally sound. The coating on the underside of the bowl is in poor condition, with large areas that were missed during the last coating.

**Figure 14.** Areas that were missed during the last coating

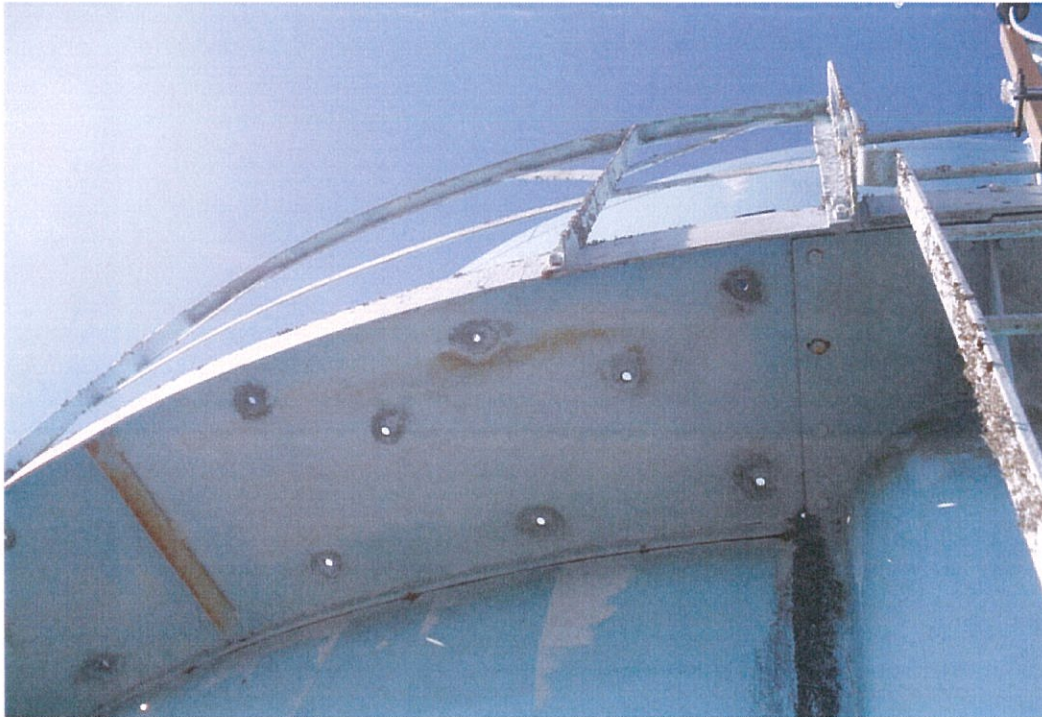
**Figure 15.** Coating failure under balcony floor

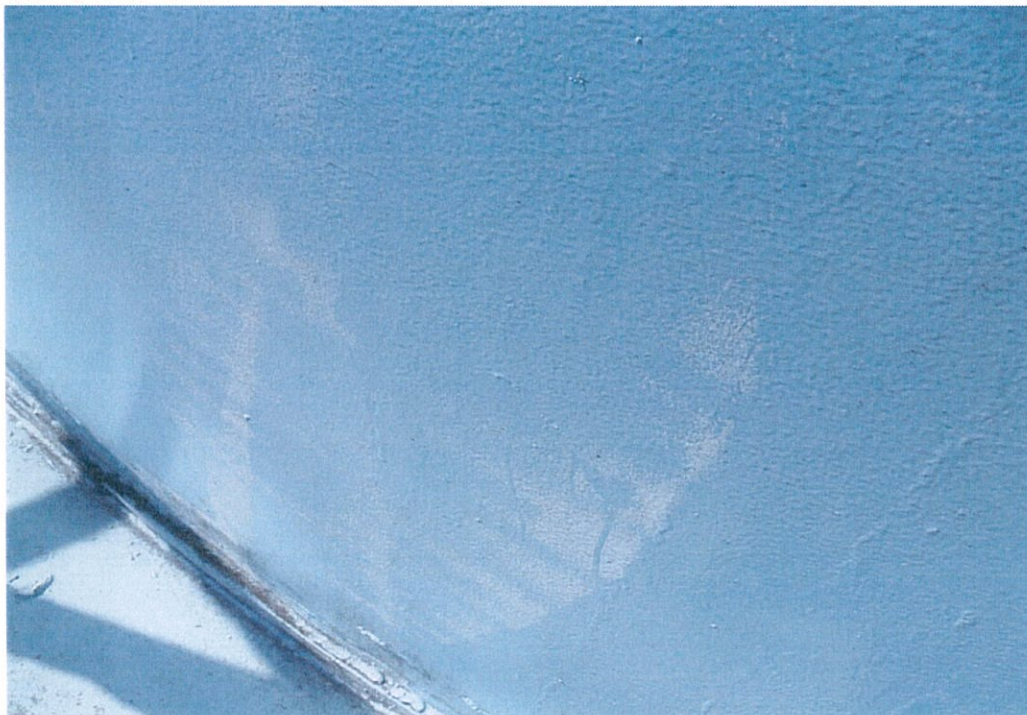
The coating system on the shell wall is in poor condition. There is complete coating failure in areas that were missed during the last coating. These areas are showing an average coating thickness of 1.8 mils. There is a secondary manway in the shell wall, but it is outdated.

**Figure 16.** Area missed during last coating on tank shell wall

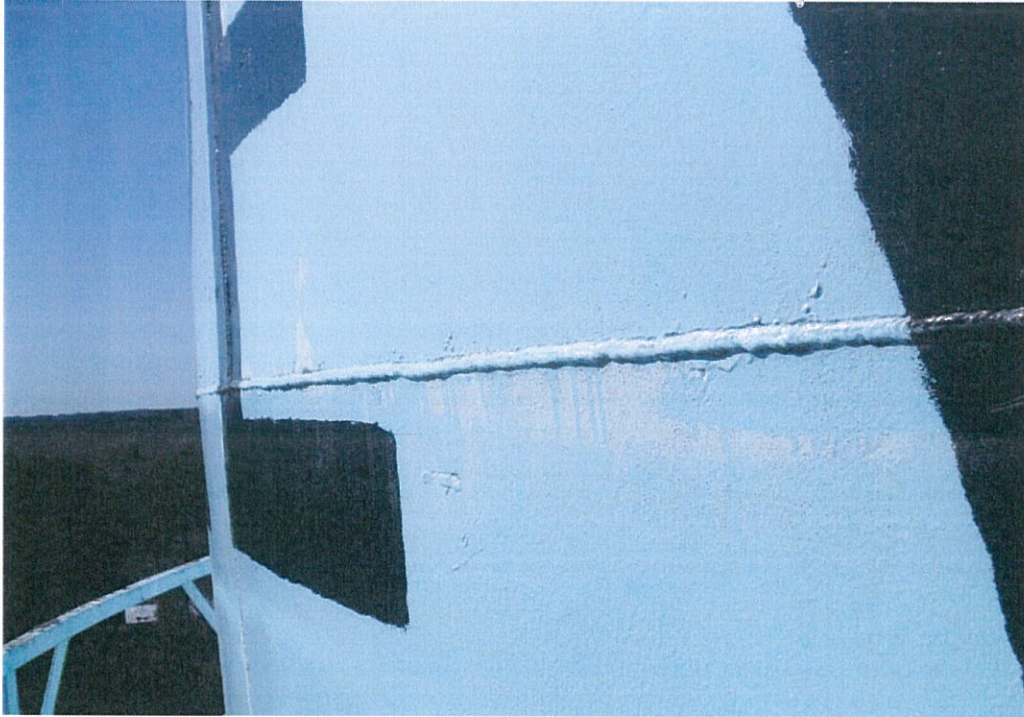
**Figure 17.** Area on shell wall missed during last coating

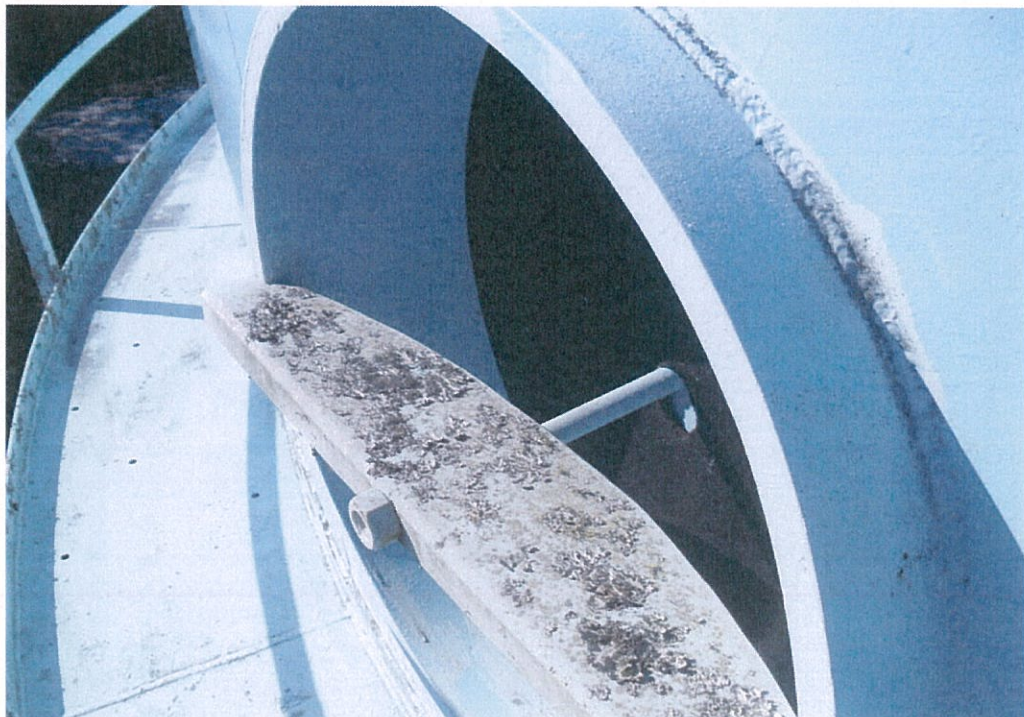
**Figure 18.** Condition of secondary shell wall manway

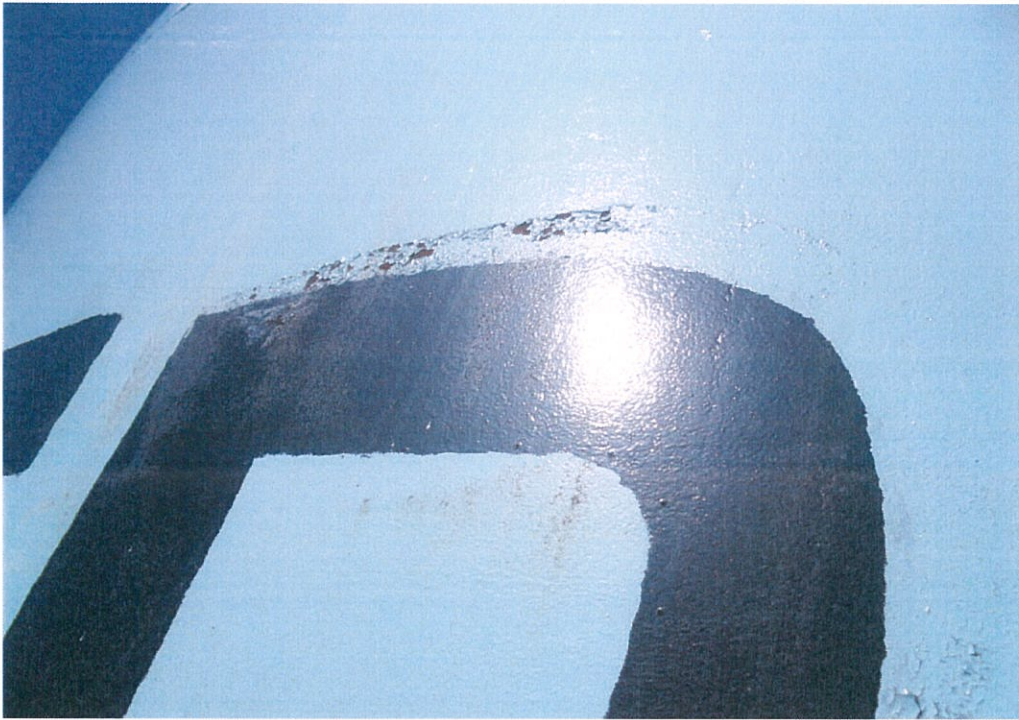
**Figure 19.** Small area of coating failure on shell wall

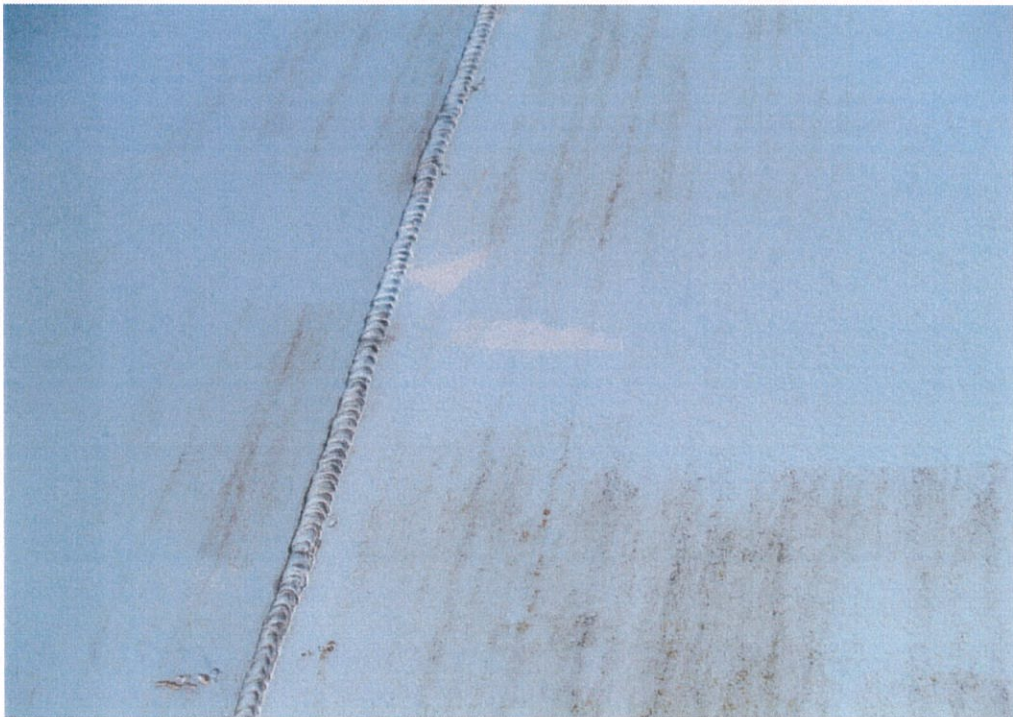
**Figure 20.** Coating failure on shell wall

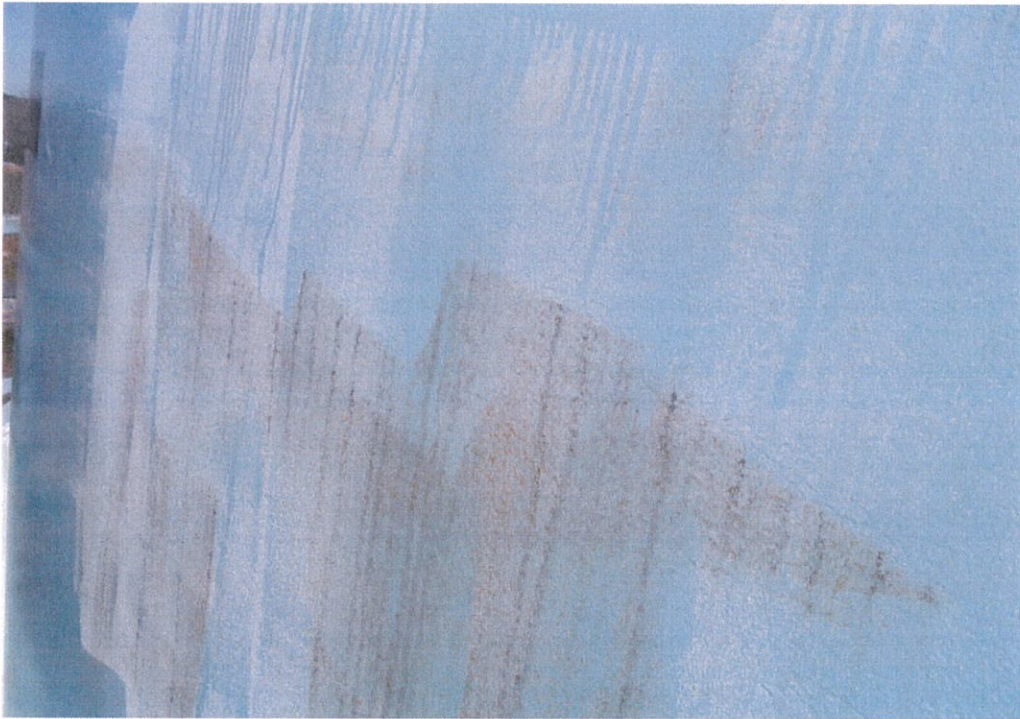
**Figure 21.** Coating failure on shell wall

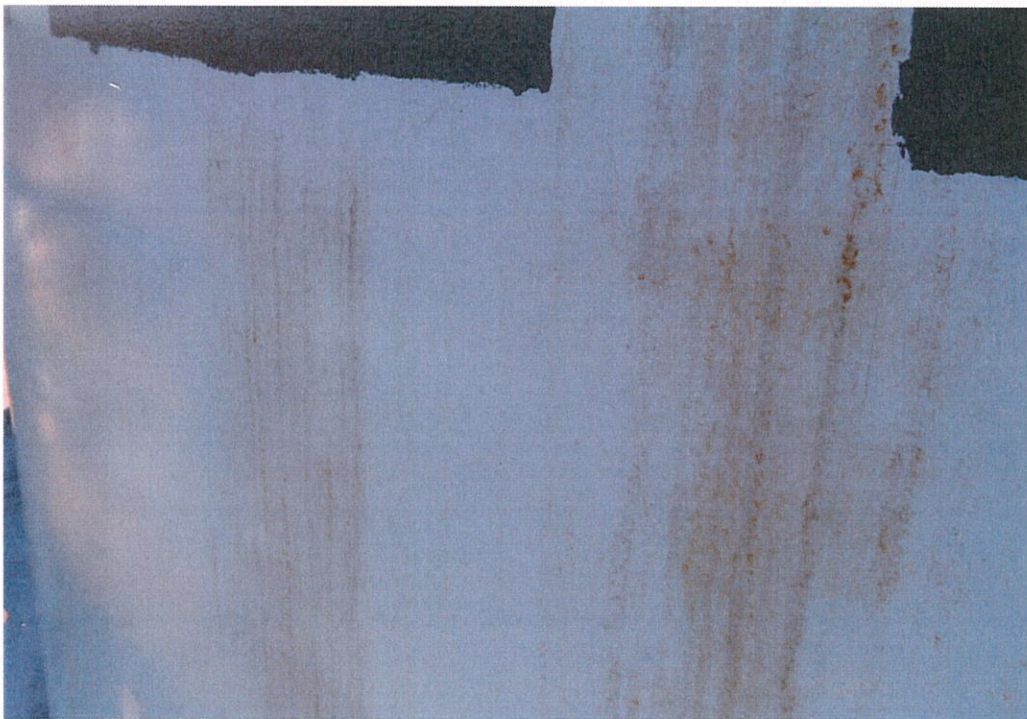
**Figure 22.** Coating failure on shell wall

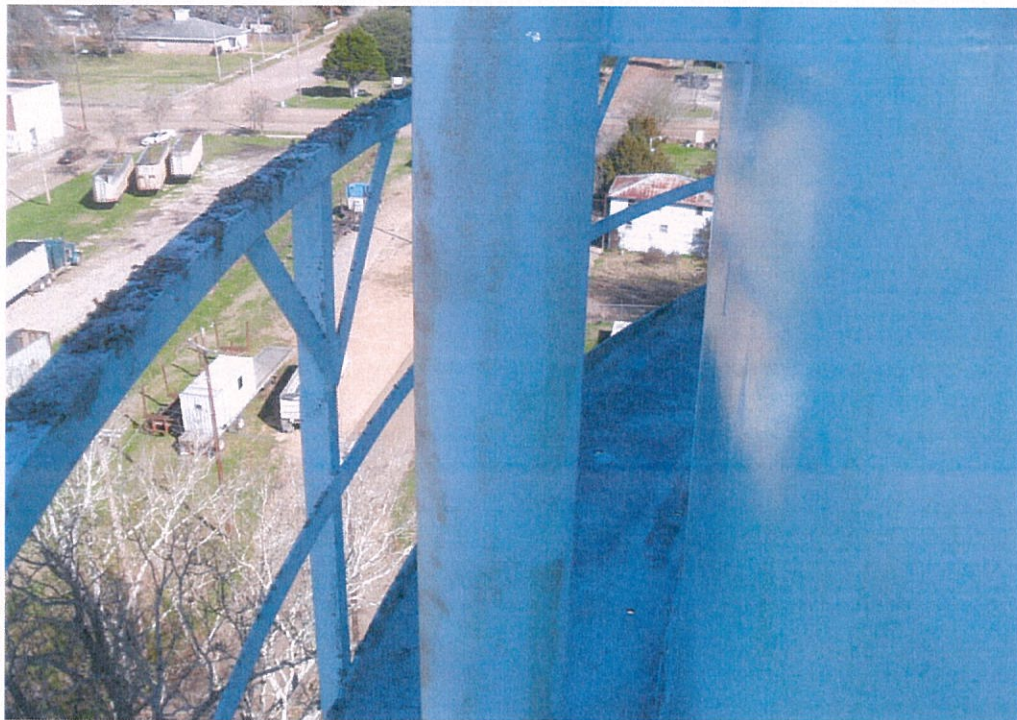
**Figure 23.** Coating failure on overflow

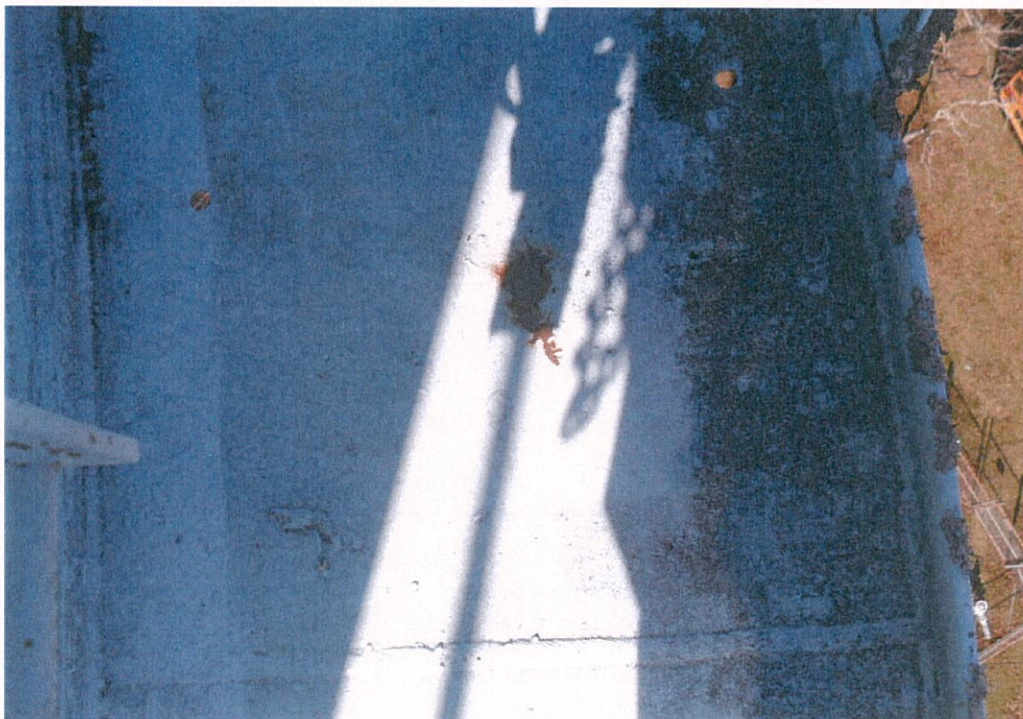
**Figure 24.** Coating failure on balcony floor

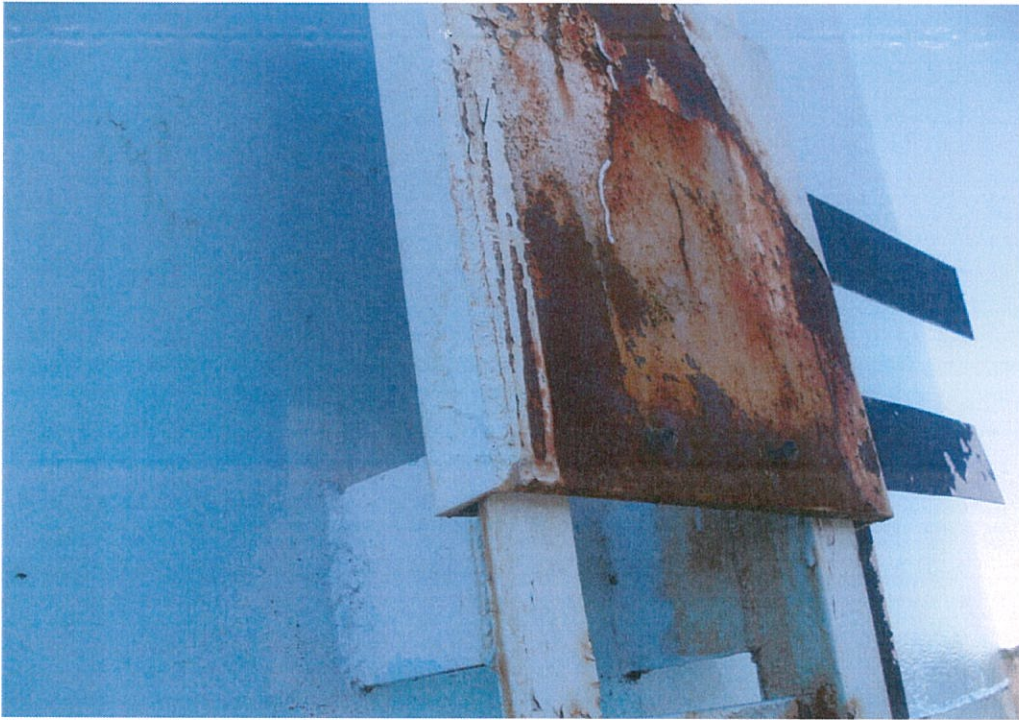
**Figure 25.** Coating failure on tank level indicator

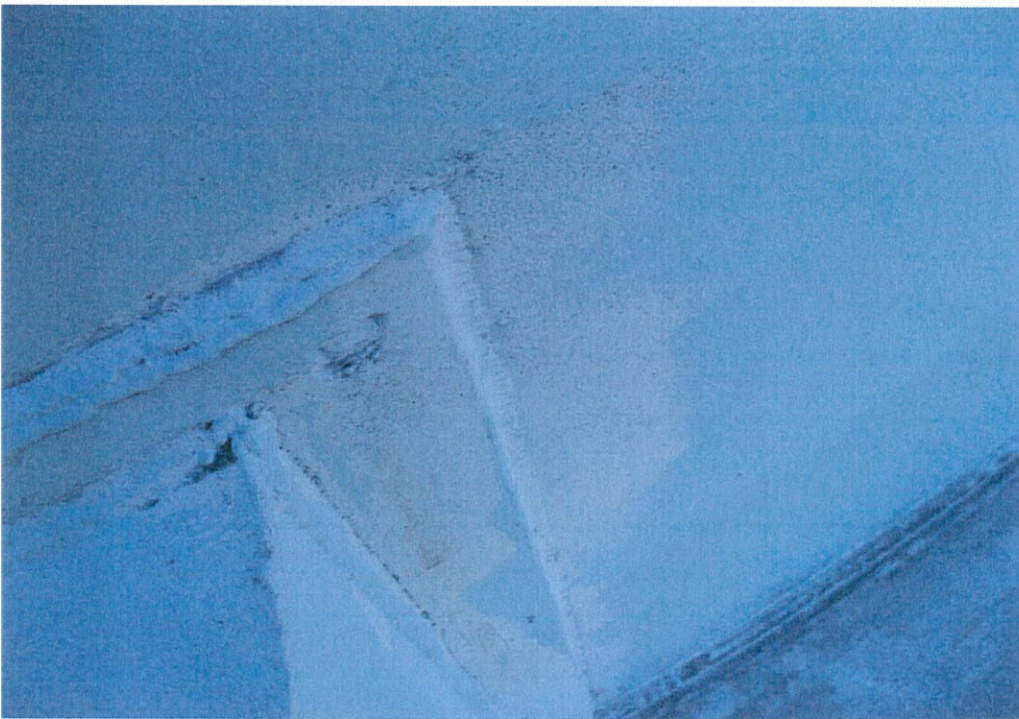
**Figure 26.** Uncoated area on tank column flange above balcony

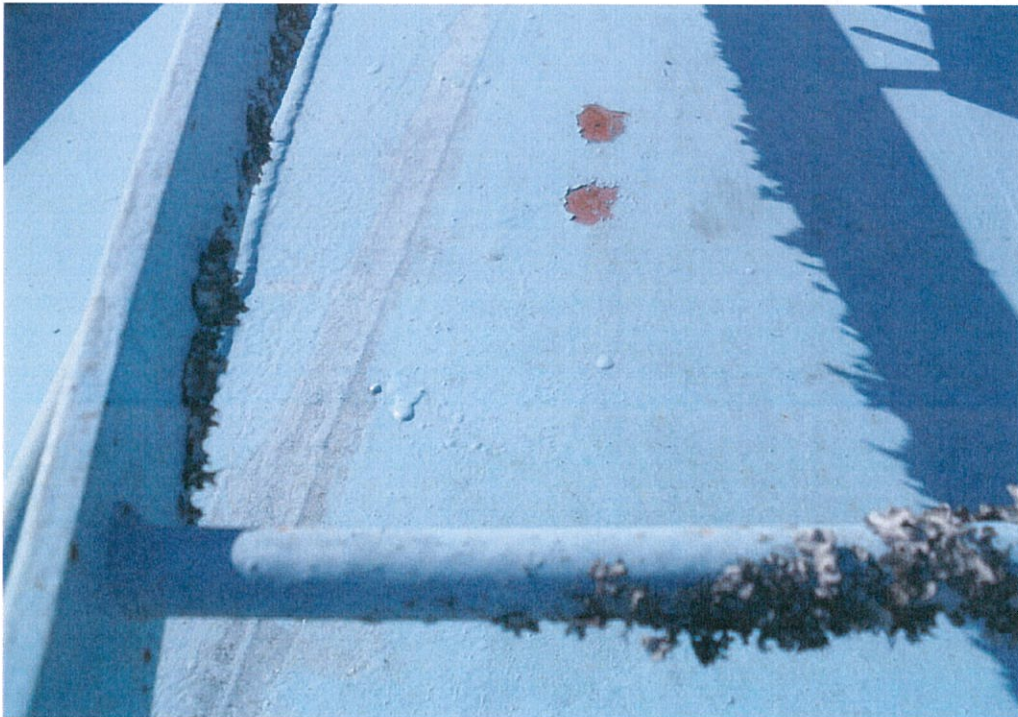
The coating on the roof of the tank is in poor condition. There is complete coating failure on the areas that were missed during the last coating. The roof manway was found unlocked.

**Figure 27.** Area missed during last coating and two localized areas of coating failure on roof of tank.

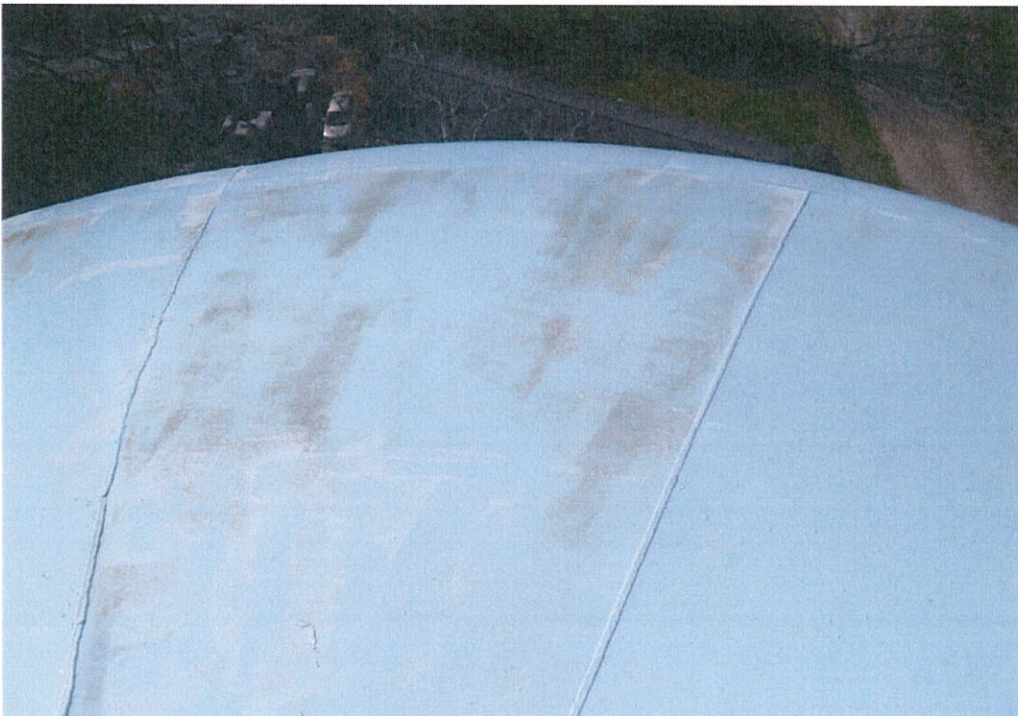
**Figure 28.** Coating failure on roof of tank

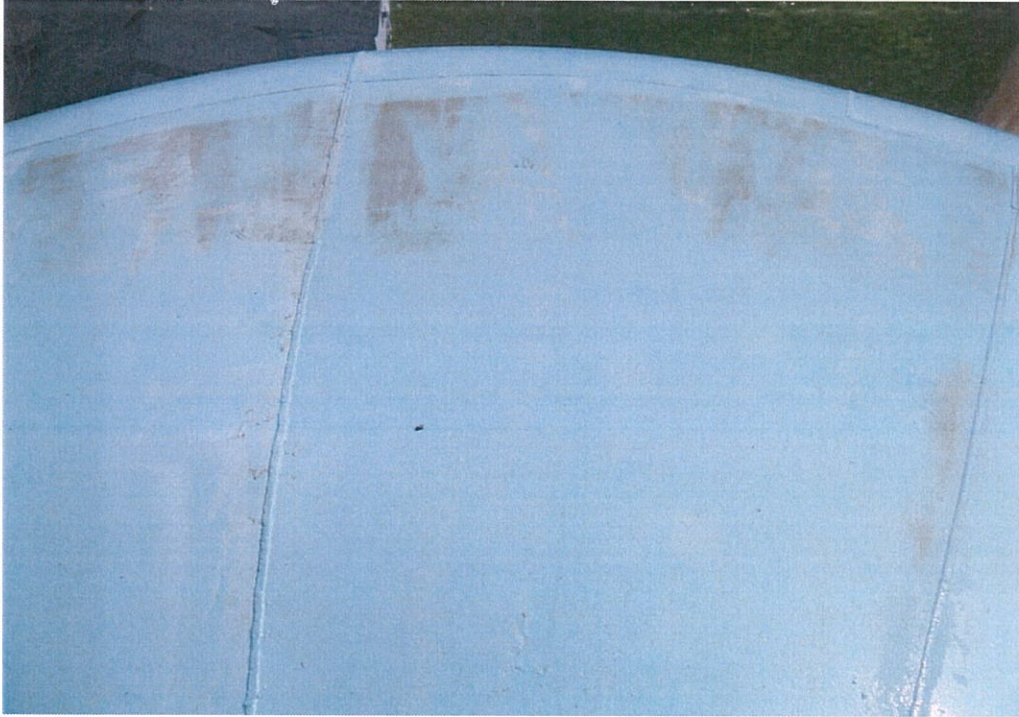
**Figure 29.** Coating failure on tank roof

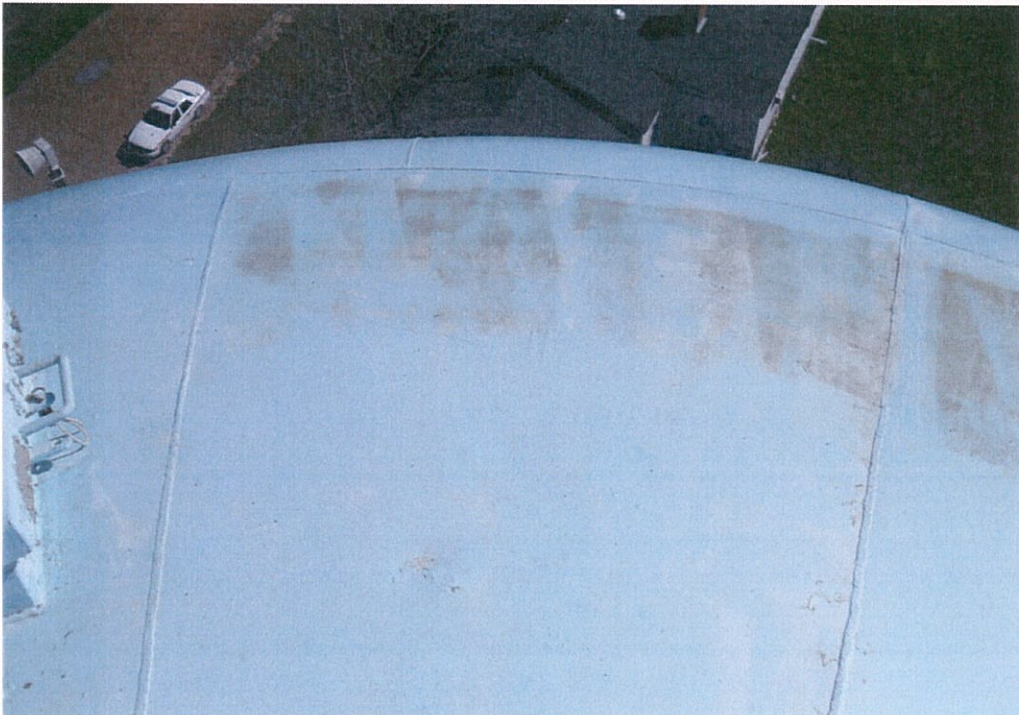
**Figure 30.** Coating failure on roof of tank
