**Elevated Tank Inspection  
Town of Centreville  
Joseph Street Elevated Tank  
January 20, 2020**

Dungan Engineering, P.A.  
120 East Chickasaw Street  
Brookhaven, MS 39601

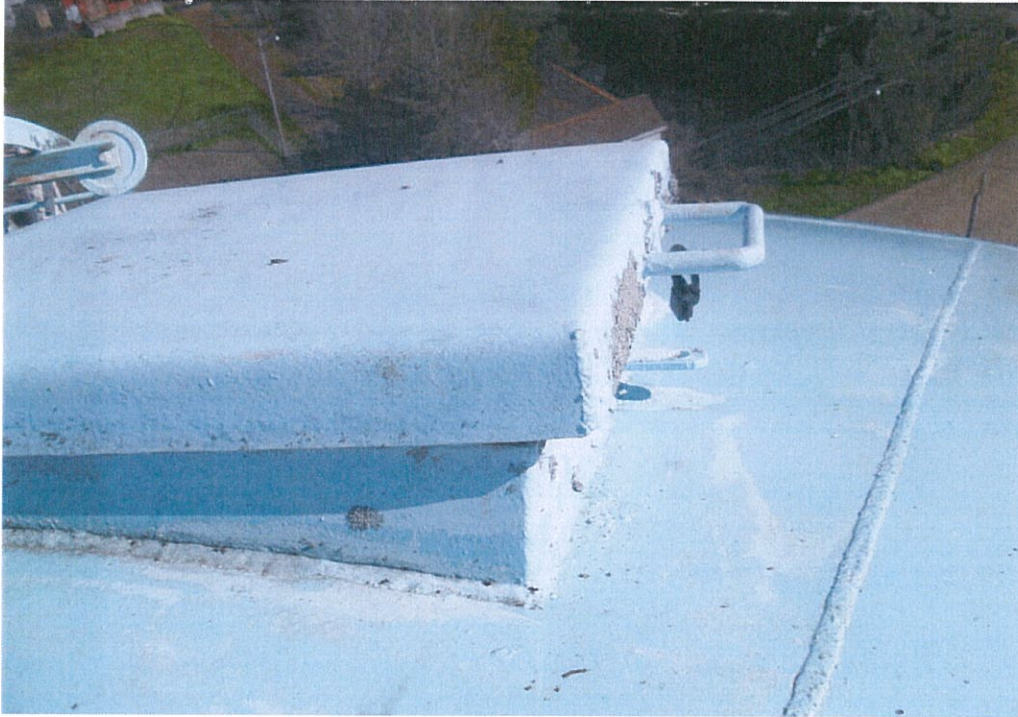
**Figure 31.** Unlocked hatch. Door is warped, lock wouldn't reach.

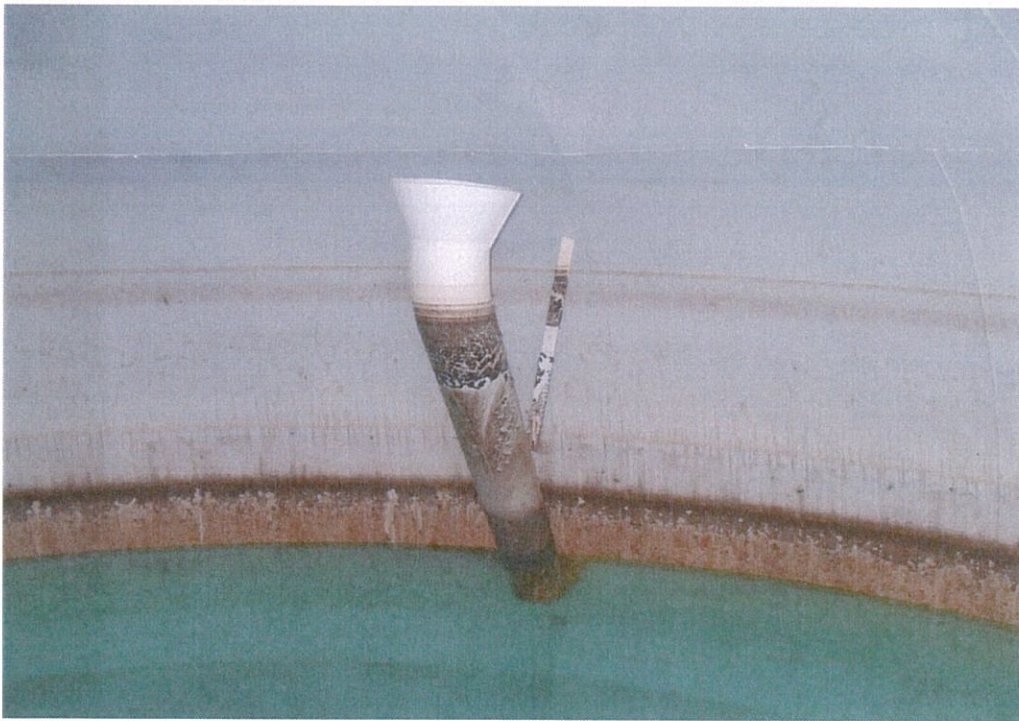
**Figure 32.** Heavy sediment on interior wall and overflow

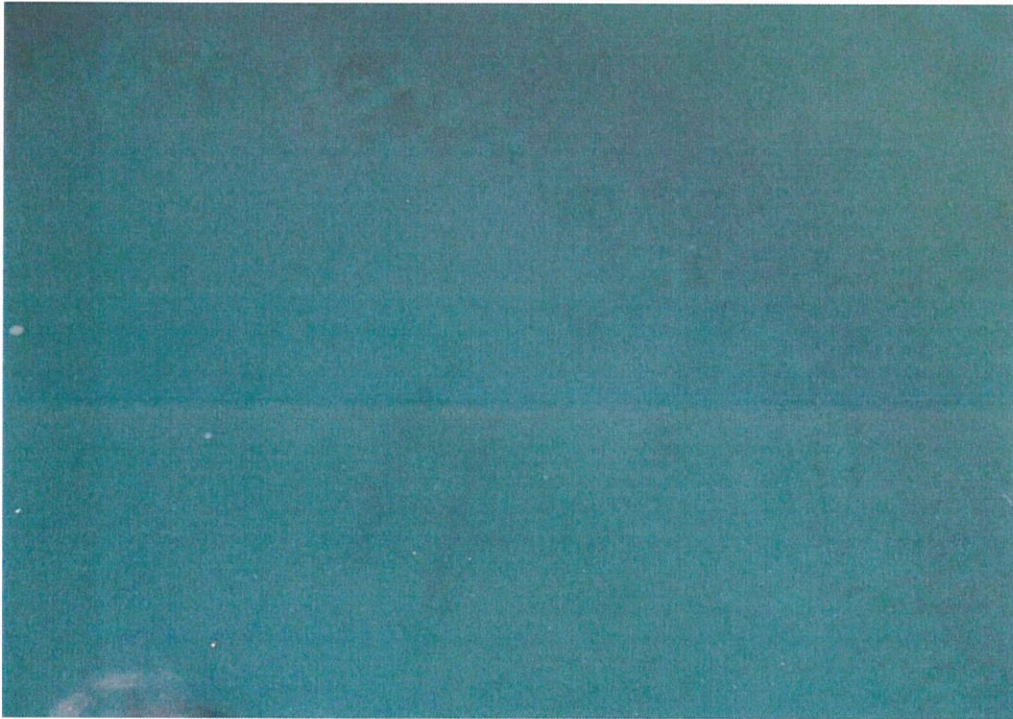
**Figure 33.** Heavy sediment and riser grate out of place

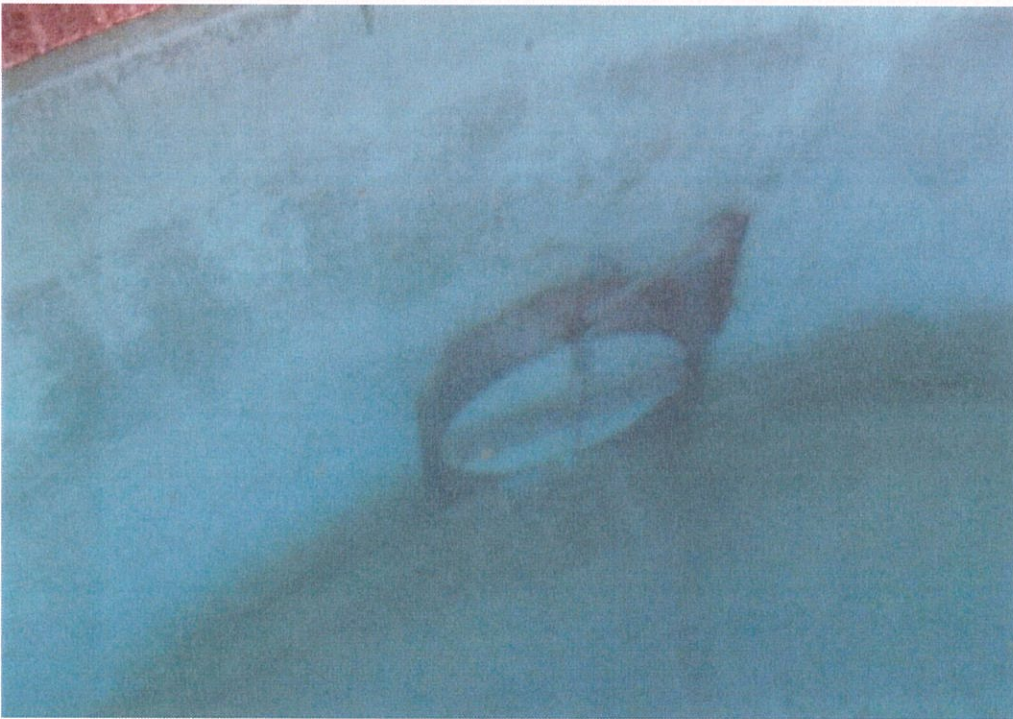
**Figure 34.** Heavy sediment on interior wall and secondary manway

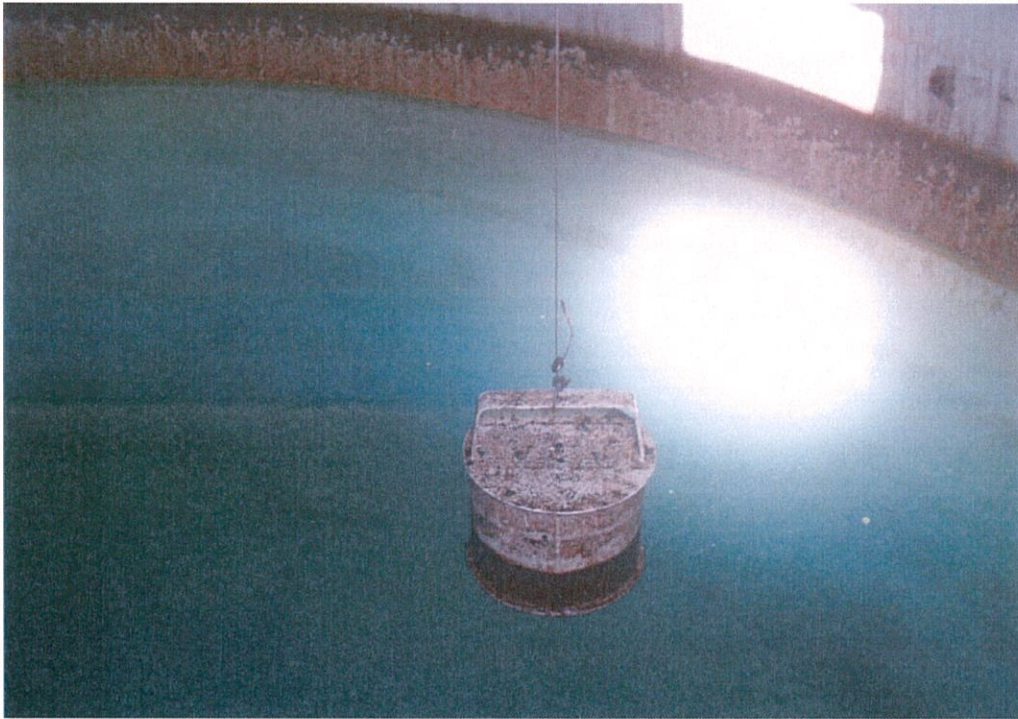
**Figure 35.** Heavy sediment on interior walls and non-functioning water level indicator.

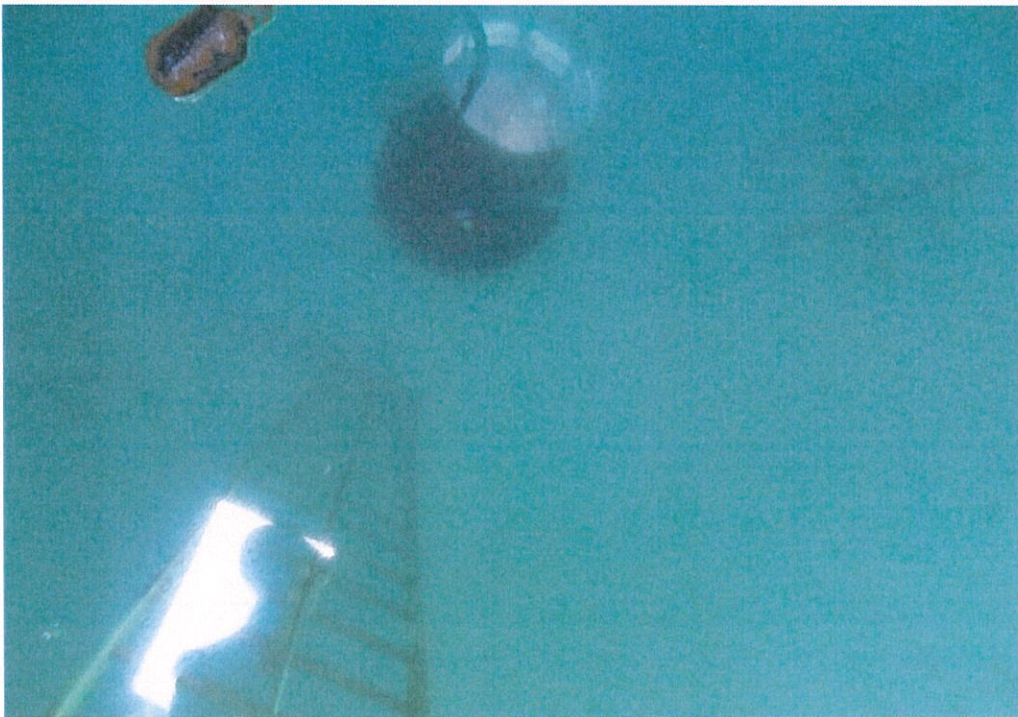
**Figure 36.** Interior ladder and ladder safety climb

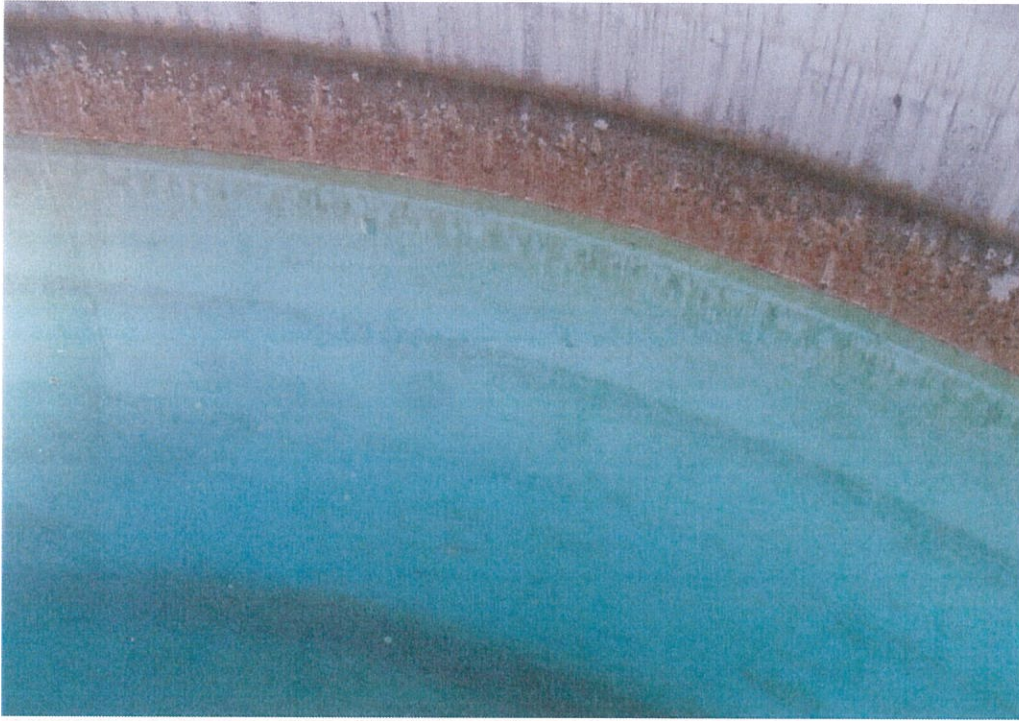
**Figure 37.** Heavy sediment on interior wall

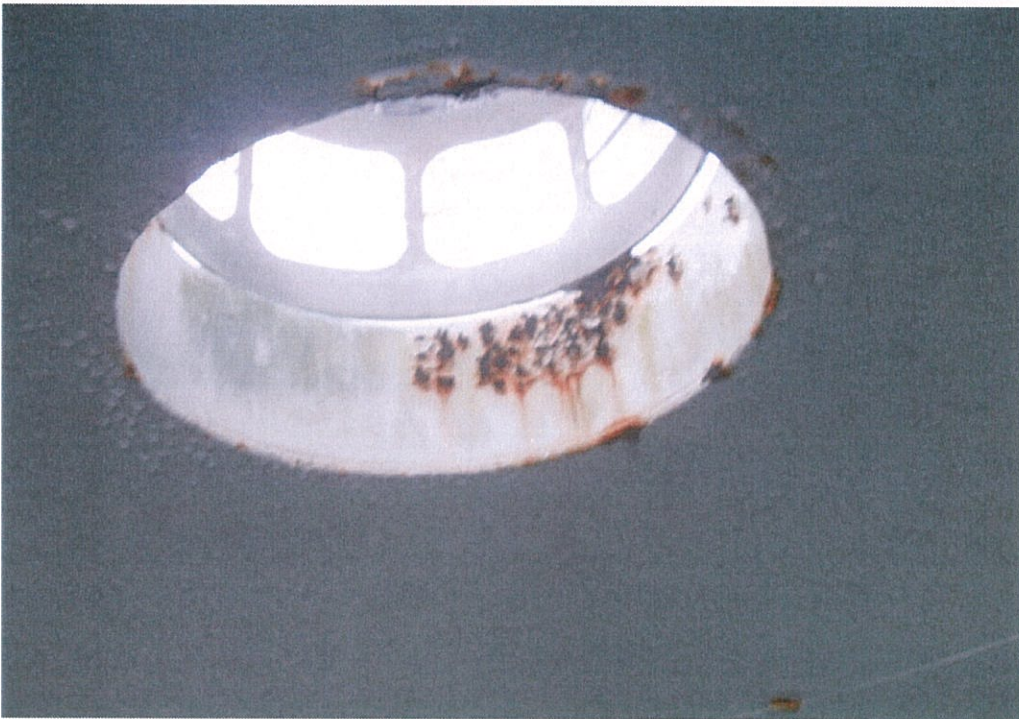
**Figure 38.** Coating failure on tank roof vent

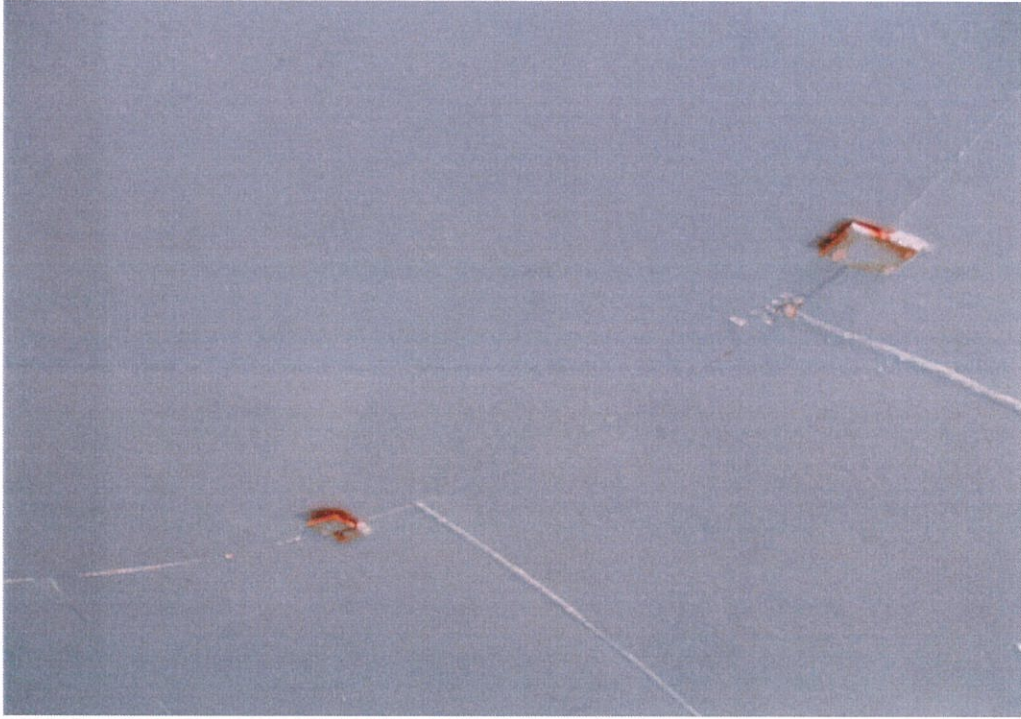
**Figure 39.** Coating failure on roof brackets

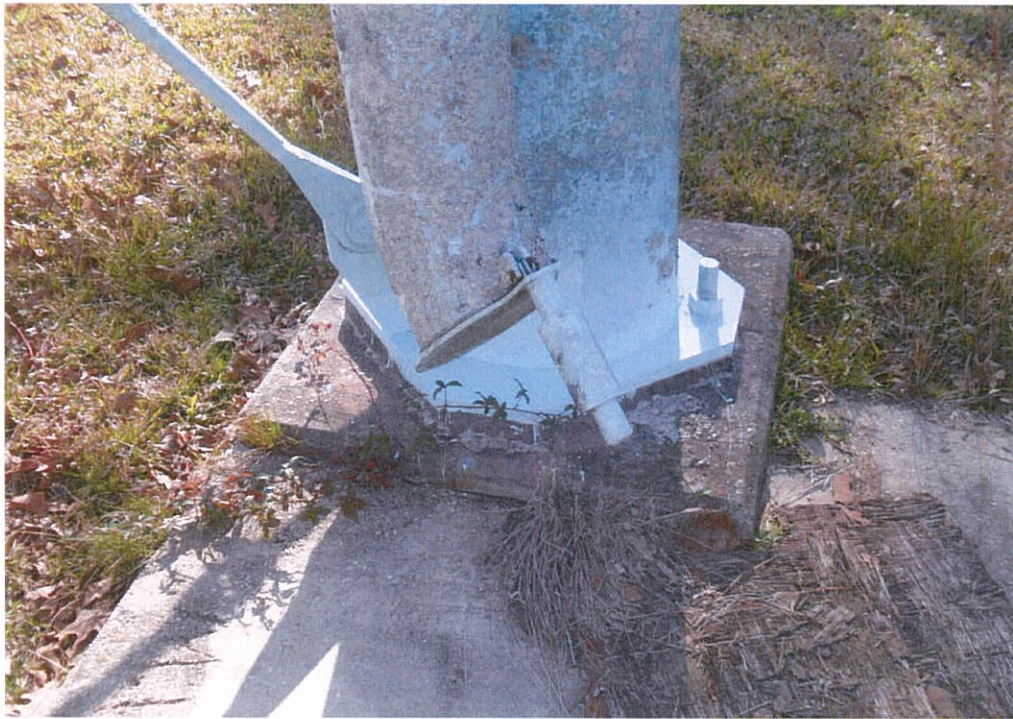
**Figure 40.** Overflow with flapper and splash pad
